NATIONAL BUREAU OF STANDARDS REPORT

9871

HAIL RESISTANCE OF ROOFING PRODUCTS

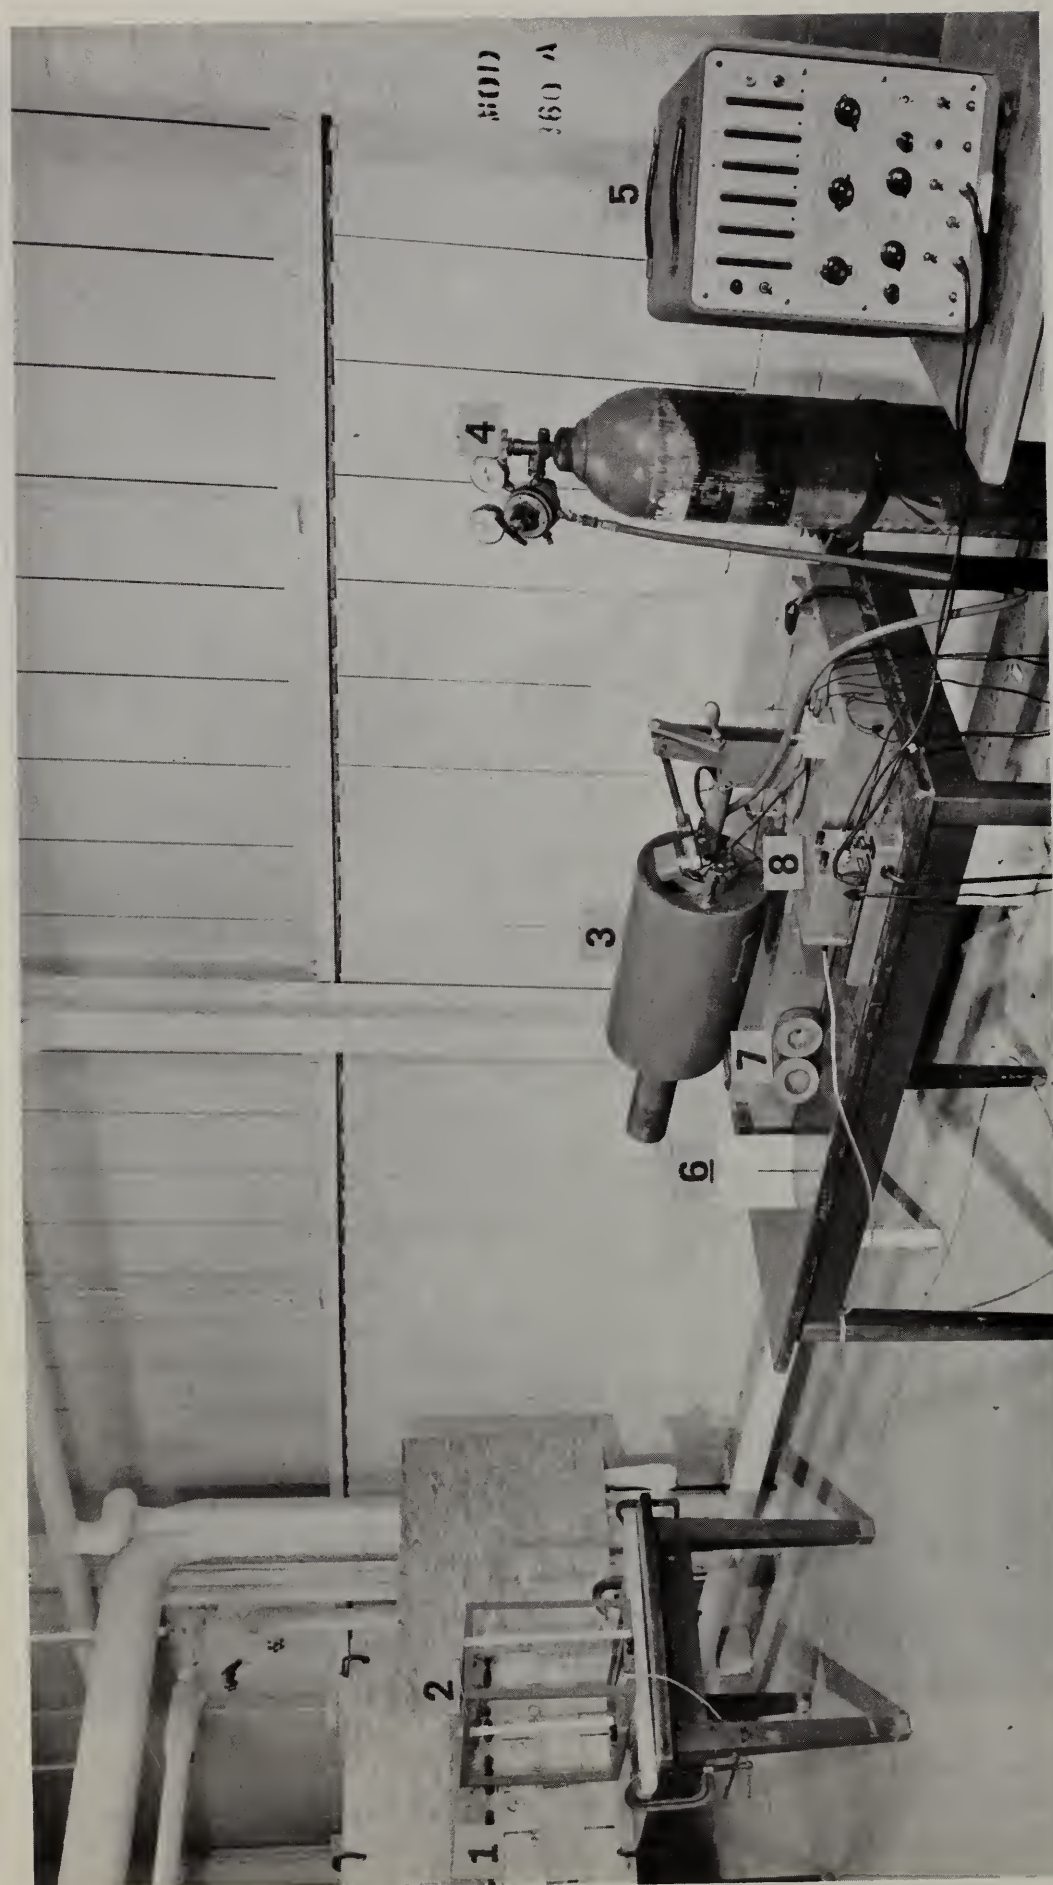
Figure 2 - Hail-Resistance Apparatus

The apparatus consisted of a compressed air gun, for launching the hailstones, a timer, for determining their velocity, and a target area, for positioning the specimen to be tested. The physical layout of the apparatus is shown in Figure 2.

Reading from left to right, the apparatus consisted of a specimen (target) area (1), a timing range (2), the gas gun (3), the gas cylinder (4), the timer (5), hailstone carrier (6), the hailstone molds (7) and the triggering mechanism (8). The roofing specimen to be tested is mounted on a roof deck, just as in service, and clamped in place against the backstop in position (1). The timing range consists of a metal frame of 3/4-inch angle iron on which are mounted two microswitches 2.0 feet apart. The actuating levers on the microswitches contain metal hooks, which are used to hold one end of one-inch computer tapes, the other ends of which are fastened to the top members of the frames with masking tape, also 2.0 feet apart. The tapes are kept under tension such that any impact on them will close the microswitches and actuate the triggering mechanism to start and stop the counter (5).

The compressed air gun (4) is a commercially available device manufactured by Diamond King, Inc. (El Segundo, California). It is their Mark 14 model, with a 3-1/4 inch inside diameter barrel and a maximum muzzle velocity of 300 ft/sec. The counter is a Hewlett-Packard Model No. 523B microsecond counter, with both starting and stopping gates and a direct readout.

The specimen on its deck was held against the backstop in Figure 2 with large C clamps. The 1-inch computer tapes were hooked to the microswitches and fastened under tension, just insufficient to close the switches, with masking tape to the top of the timing frame. A hailstone of the desired size was taken from the freezer, cleaned of any burrs or projecting pieces of ice (from the gate in the mold), weighed, and placed in its carrier, which was slid into the barrel of the gun as far as possible. Air, or nitrogen, was permitted to enter the gun until the desired pressure was reached. The valves between the gun and the tank were closed (to protect the pressure regulator), the pressure gage was removed from the gun, and the gun was fired by opening the solenoid valve.
